R22 SERVICE BULLETIN SB-103

SUBJECT: Main Rotor Blade Bond Inspection

ROTORCRAFT AFFECTED: R22-series helicopters with A016-4 main rotor blades.

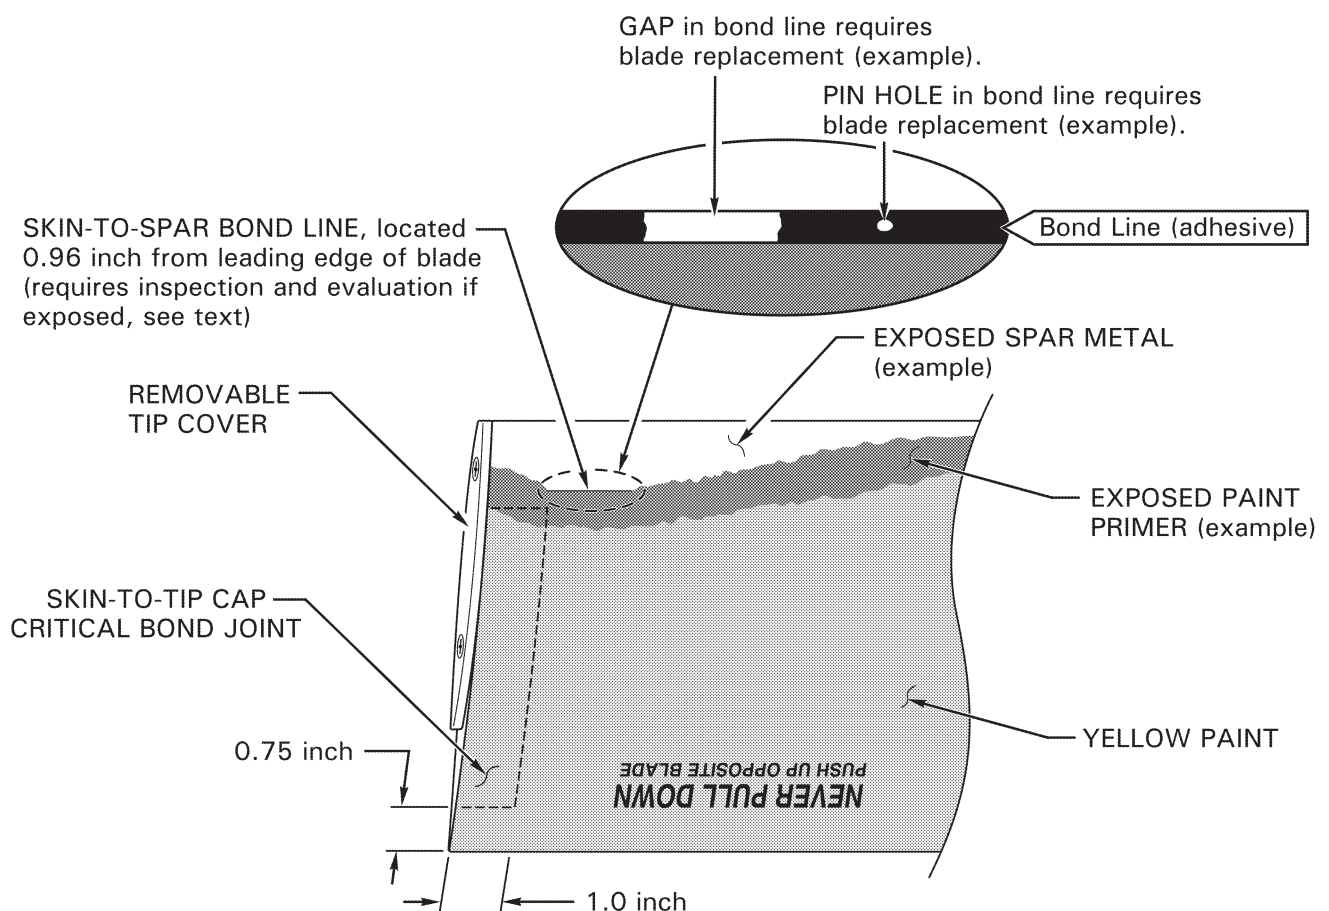
BACKGROUND: Debonding of rotor blade skins can occur when the bond line is exposed due to erosion of the blade finish, or when corrosion occurs on the internal aluminum tip cap. Proper inspection and protection (refinishing) of bonded areas is required. Debonding resulting from improper inspection and maintenance could cause a catastrophic accident.

FIGURE 1 TIP AREA AND LOWER SURFACE
(Example, Blade with Excessive Paint Erosion)

1. Refer to Figures 1 and 2. Remove both main rotor blade tip covers and clean the blades.
2. Using 10x magnification, visually inspect uncovered skin-to-tip cap bond joints. Using a 1965-or-later United States quarter-dollar coin, tap test skin-to-tip cap bond joints on both upper and lower surfaces. If corrosion, separation, or voids are detected, blade is unairworthy. Tap test tutorial video is available at: www.robinsonheli.com/support.htm.
3. Using 10x magnification, visually inspect any exposed skin-to-spar bond line for gaps (empty space between skin and spar). Blade is unairworthy if any gap, including "pin hole(s)", is detected in the bond line.
4. Refer to Figure 2. Mark outboard 120 inches of blade lower surface as shown to identify skin-to-spar bond joint area.
5. Verify no visible dents within the bond joint area. Blade is unairworthy if bond joint area is dented.

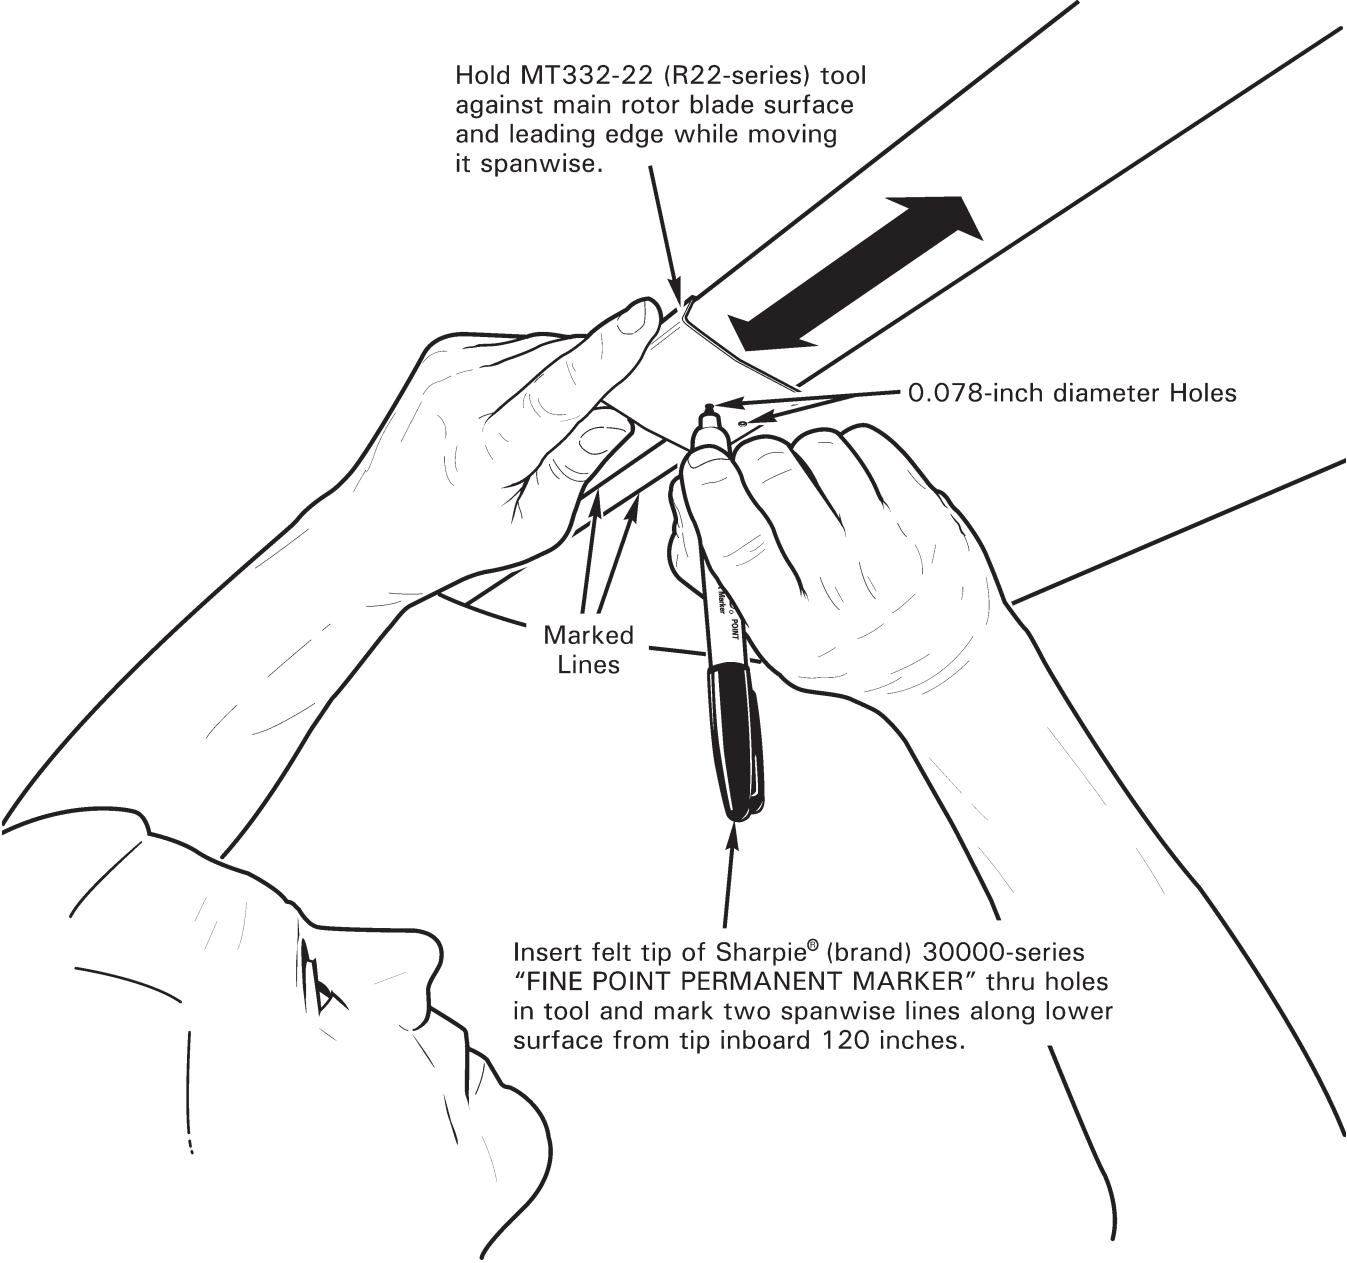
FIGURE 2 MARKING LOWER SKIN-TO-SPAR BOND JOINT AREA

6. Tap test the lower skin-to-spar bond joint and verify no voids exist. Blade is unairworthy if a void is detected.
7. Refinish all exposed bare metal per R22 SL-56B.
8. Install blade tip covers.
9. Make appropriate maintenance record entries.
