SERVICE BULLETIN SB-58A

SUBJECT: R44 II Throttle Link

ROTORCRAFT AFFECTED: R44 II Helicopters S/N 10001 thru 11367 except S/N 11063, 11293, 11320, 11347, 11350, 11354, 11359, 11362, and 11364.

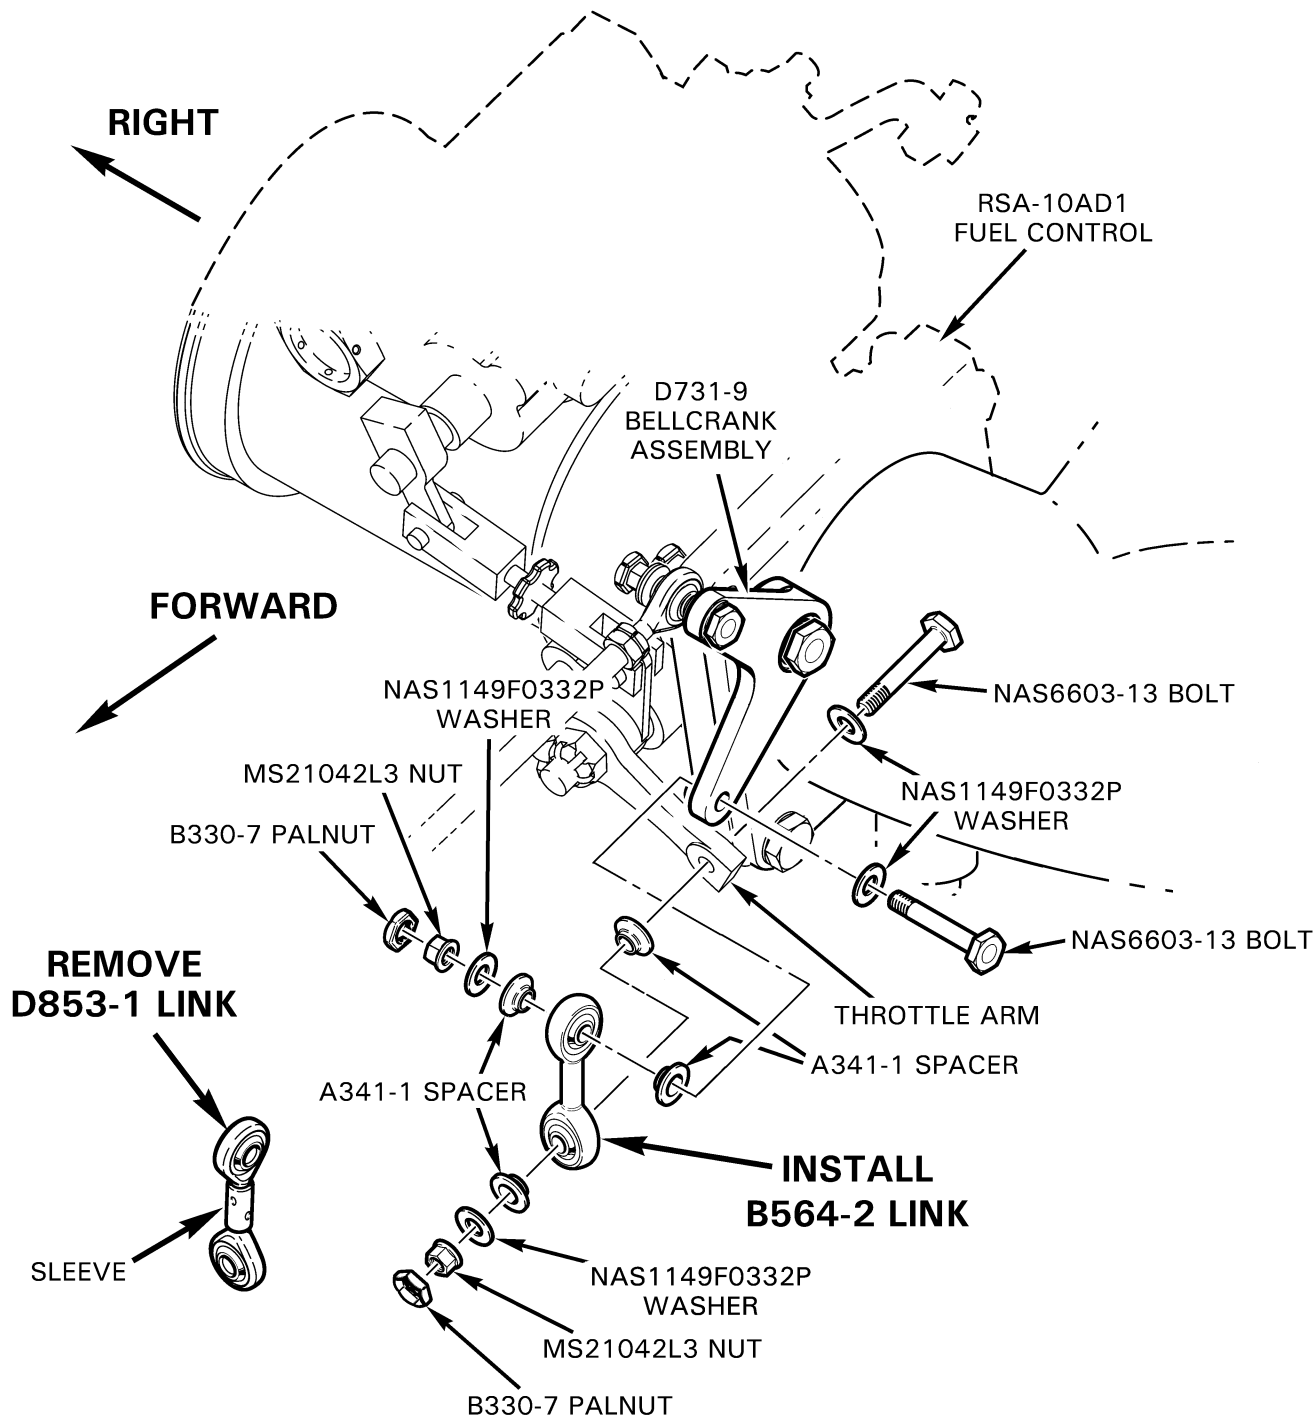
BACKGROUND: Since issuance of SB-58, RHC has received an additional report of a failed D853-1 throttle link assembly. Immediate inspection of existing parts is required to ensure airworthiness.

1. Refer to figure on page 2. Verify no looseness between sleeve and either rod end of D853-1 link. If looseness is detected, replace link before further flight.

1. Order B564-2 link from RHC Customer Service.
2. Refer to figure on page 2. Remove D853-1 link assembly and install B564-2 link. Torque nuts to 50 in.-lb, palnuts to 10 in.-lb, and torque stripe.
3. Verify throttle correlation rigging per R44 Maintenance Manual Section 10.150, Step 3.
4. Make appropriate maintenance record entries.
