KI-185
R44 C046-18 FRAME TUBE CLAMP INSTALLATION KIT

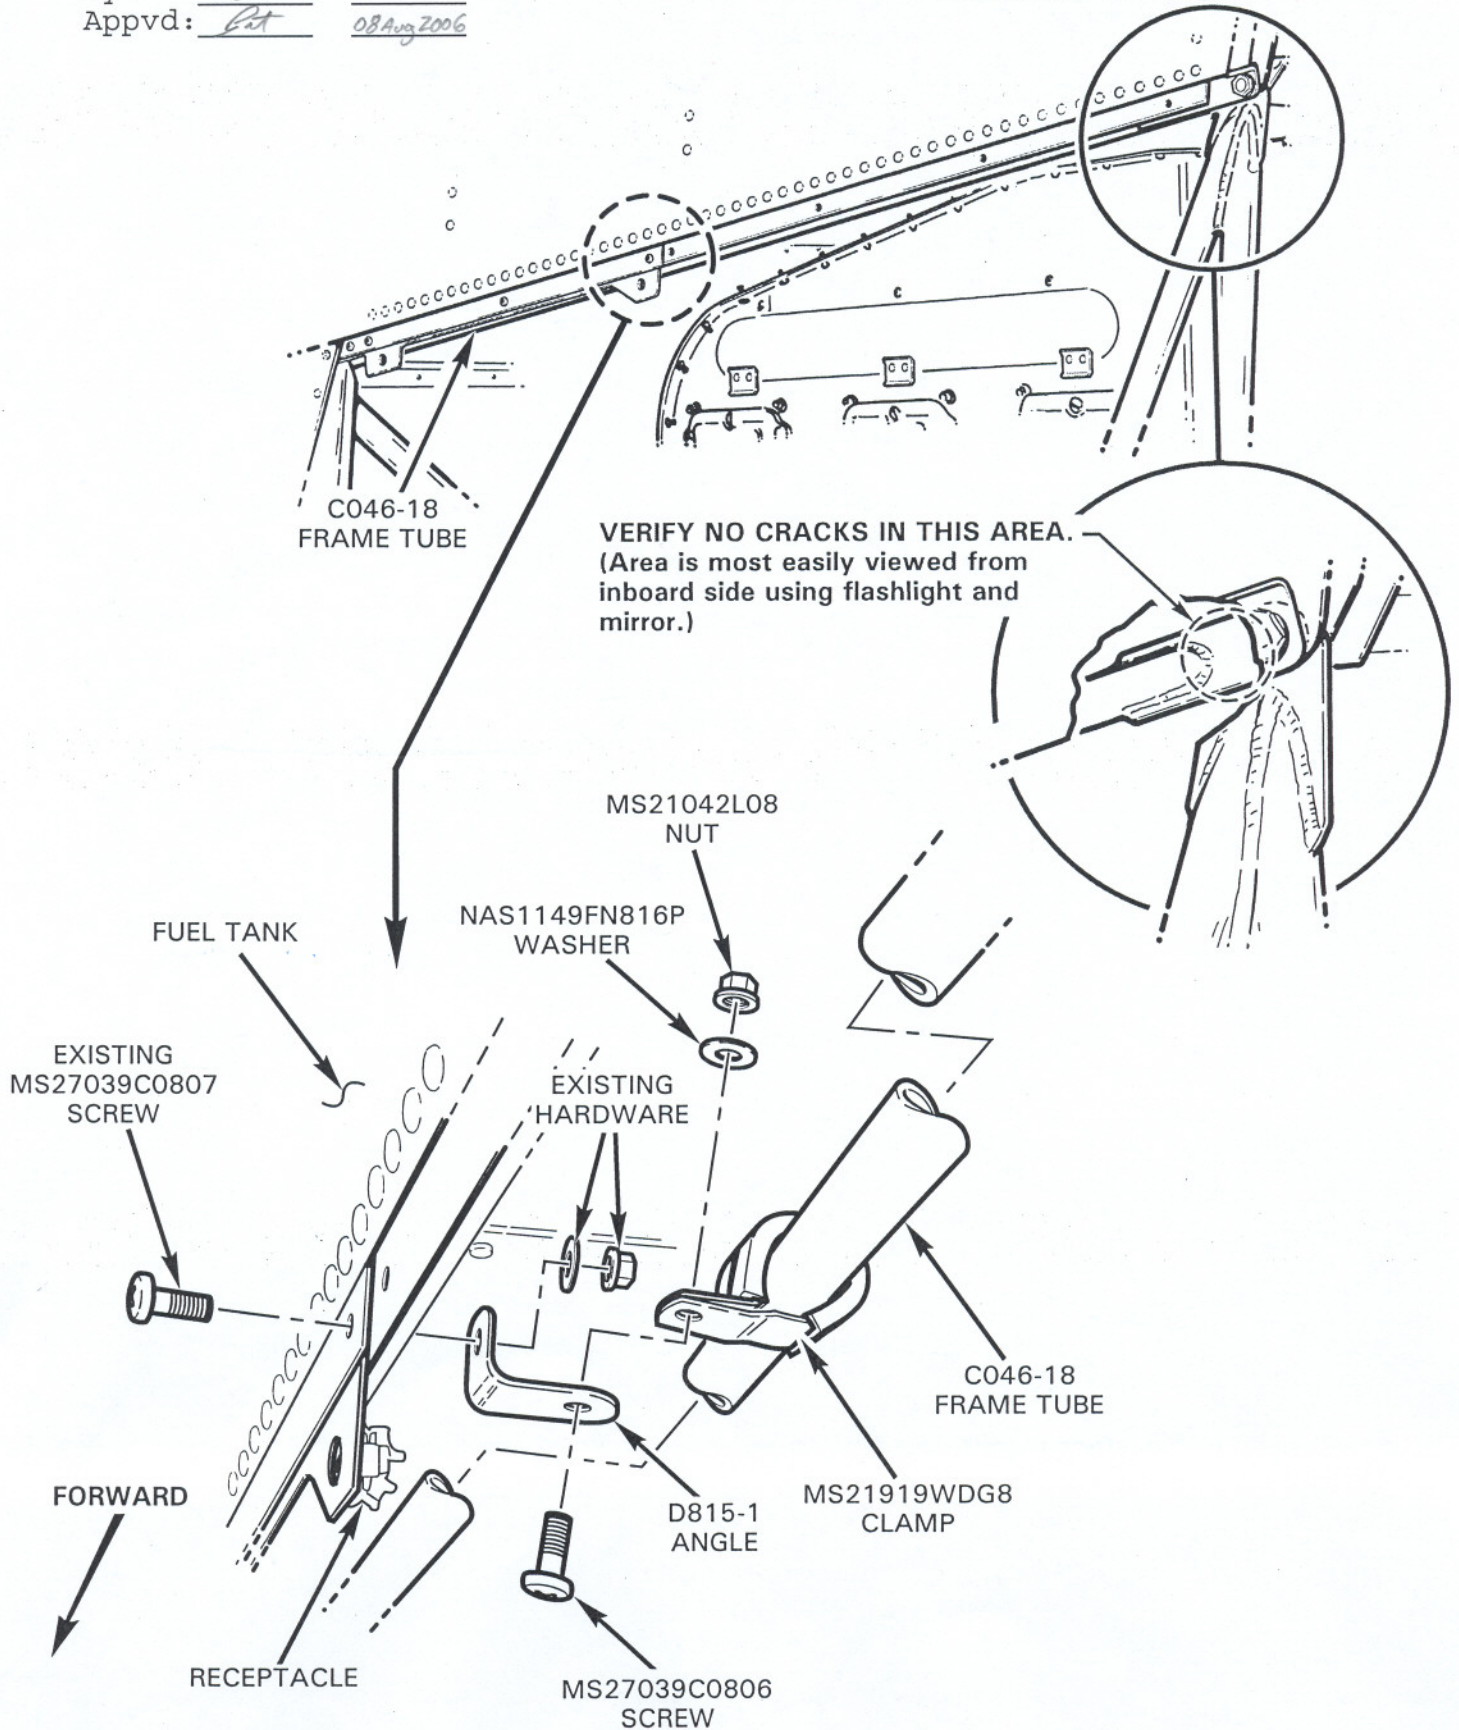
1. Verify kit contents match above list. Contact RHC if any parts are missing or damaged.
2. Remove left-side engine cowl.
3. Refer to figure on page 2. Visually inspect aft tab of C046-18 tube in area indicated to verify no cracks. If tab is cracked, replace C046-21 lower frame assembly or contact RHC Technical Support for repair instructions.
4. Remove MS27039C0807 screw adjacent to inspection door receptacle. Retain screw, washer, and nut.
5. Install D815-1 angle and MS21919WDG8 clamp as shown in figure.
6. Install left-side engine cowl.
7. Make appropriate maintenance record entries.
